Short technical note

The effect of laser shock peening on the life and failure mode of a cold pilger die

Curt A. Lavender^{a,*}, Sung-Tae Hong^a, Mark T. Smith^a,
Robert T. Johnson^b, David Lahrman^c

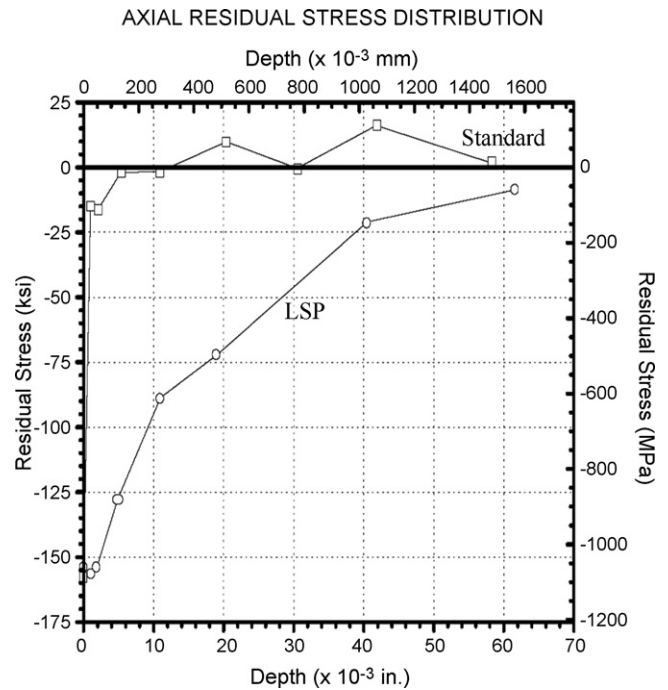
Fig. 2 – The results of the residual stress measurement for the LSP-die and the standard die.

The LSP process was effective at creating deep compressive residual stress in the root radius of the pilger die. As shown by the residual stress plot in Fig. 2, the LSP-die and the standard die showed similar compressive residual stresses (≈ 1.05 GPa) at the surface. However, at approximately 0.01 mm depth, the residual stress in the standard die dropped to near 0 whereas the residual stress in the LSP-die was still nearly 900 MPa. Remarkably the LSP-die had a compressive residual stress of approximately 200 MPa at 1 mm depth and the residual stress finally dropped to near 0 at about 1.5 mm depth.

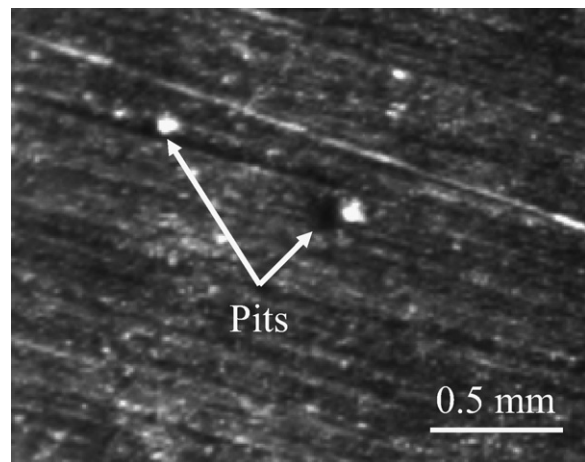
Fig. 3 – Surface appearance of the LSP-die before experiments.

The die surface finish was visually inspected after LSP, and pits were observed. The pits were attributed to the peening process and were subsequently eliminated in later LSP trials; the LSP-dies discussed in this paper had the pitting. The morphology of the pits is shown in Fig. 3 and they were found to be approximately 0.2 mm in diameter and very shallow (creating difficulties for photographing). However, even with the small pits, the LSP-die-set produced approximately 300% more tubing than the average standard production die set before failure and showed the highest die life ever measured for this pass. The increase of 300% represented a statistically significant life improvement and was more than 8 standard deviations greater than the average standard production die life.

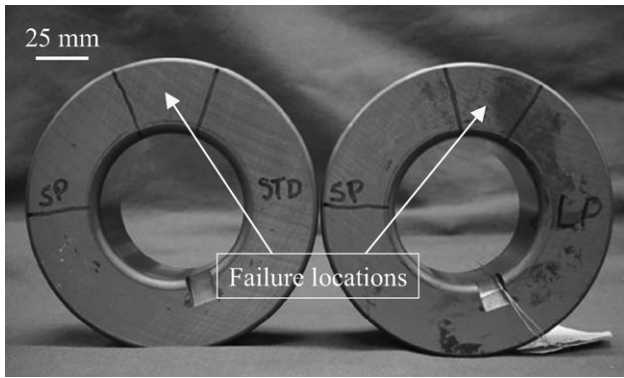
Fig. 4 – The failure locations of the LSP-die and the standard die relative to the key slot.

The LSP-die failed in nominally the same location relative to the fixed key slot position as the standard die as shown in Fig. 4 and the location is typical of standard production die failure location. Note that the location of the groove within the die is controlled by a key slot used to index the die in the grinder. The optical photographs in Fig. 5(a) and (b) show the specific regions of the die associated with the “cracked out” rating from the previously described visual inspection for the LSP-die and the standard die, respectively and suggest that the failure of the dies was related to the cracks/pits in the root of the groove. The occurrence of the failure in the root of the groove is reasonable since the pilgering process, which reduces the diameter of the tube, induced an opening mode to the groove, and it is intuitive that the highest stress should occur at the root of the groove. Importantly, Fig. 5(a) and (b) also shows that the die cracks in the standard die had propagated along the groove out of the field of view whereas the cracks in the LSP-die were rather isolated and did not propagate much. The difference in the crack propagation behavior of the LSP-die and the standard die also can be seen in the SEM micrographs in Fig. 6(a) and (b), which were taken at approximately 25 mm to the narrower end of the tapered-groove from the “cracked out” regions. Fig. 6(a) and (b) confirms that the LSP-die shows

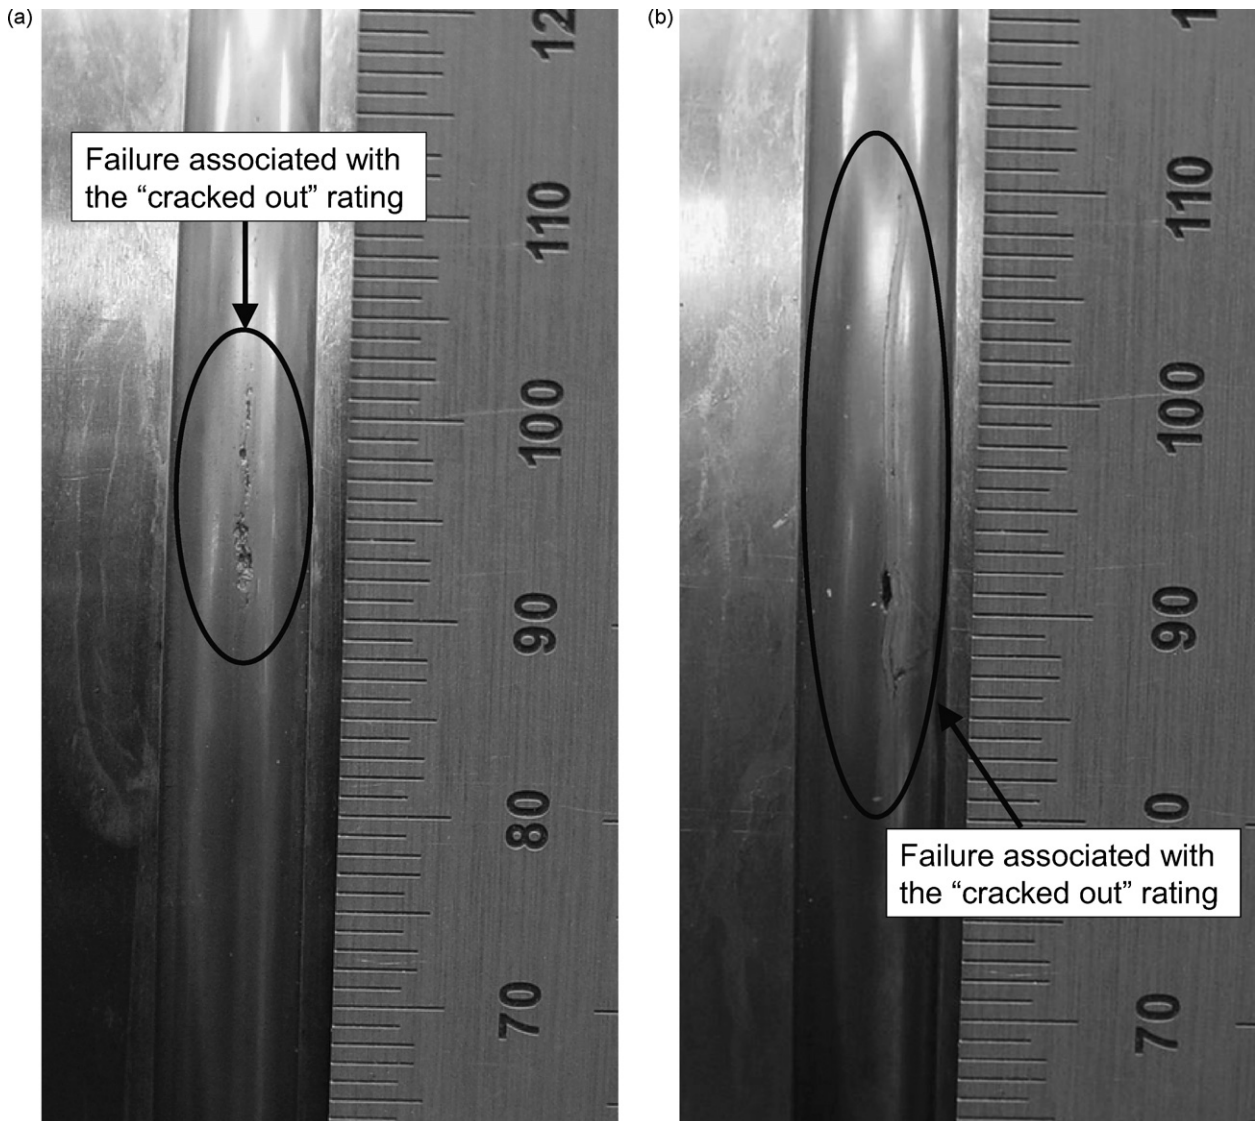
Fig. 5 – The failure regions associated with the “cracked out” rating for (a) the LSP-die and (b) the standard die, respectively. Note that the unit of the scales in the pictures is mm.

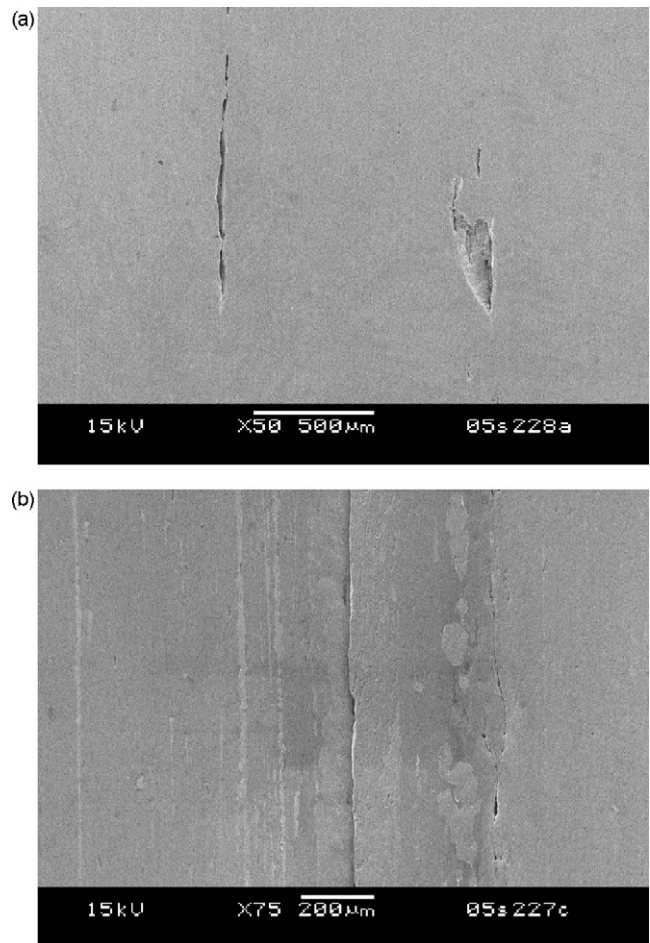
Fig. 6 – Cracked areas approximately 25 mm from the “cracked out” regions shown in Figs. 4 and 5 for (a) the LSP-die and (b) the standard die, respectively.

scattered short cracks in the damaged area in contrast to the continuous cracks in the standard die.

It is possible that the pits associated with LSP process caused the small and isolated cracks, which may accelerated the initiation of the “flaked” appearance failure of the LSP-die. Undoubtedly, the cracks would ultimately propagate and some of the LSP-die cracks are sharp, as shown in the left side of Fig. 6(a), however due to the very high compressive residual stress the crack growth rate was slowed and consequently the LSP-die failed (“cracked out”) by a different mechanism prior to the crack propagation like that observed in the standard die.

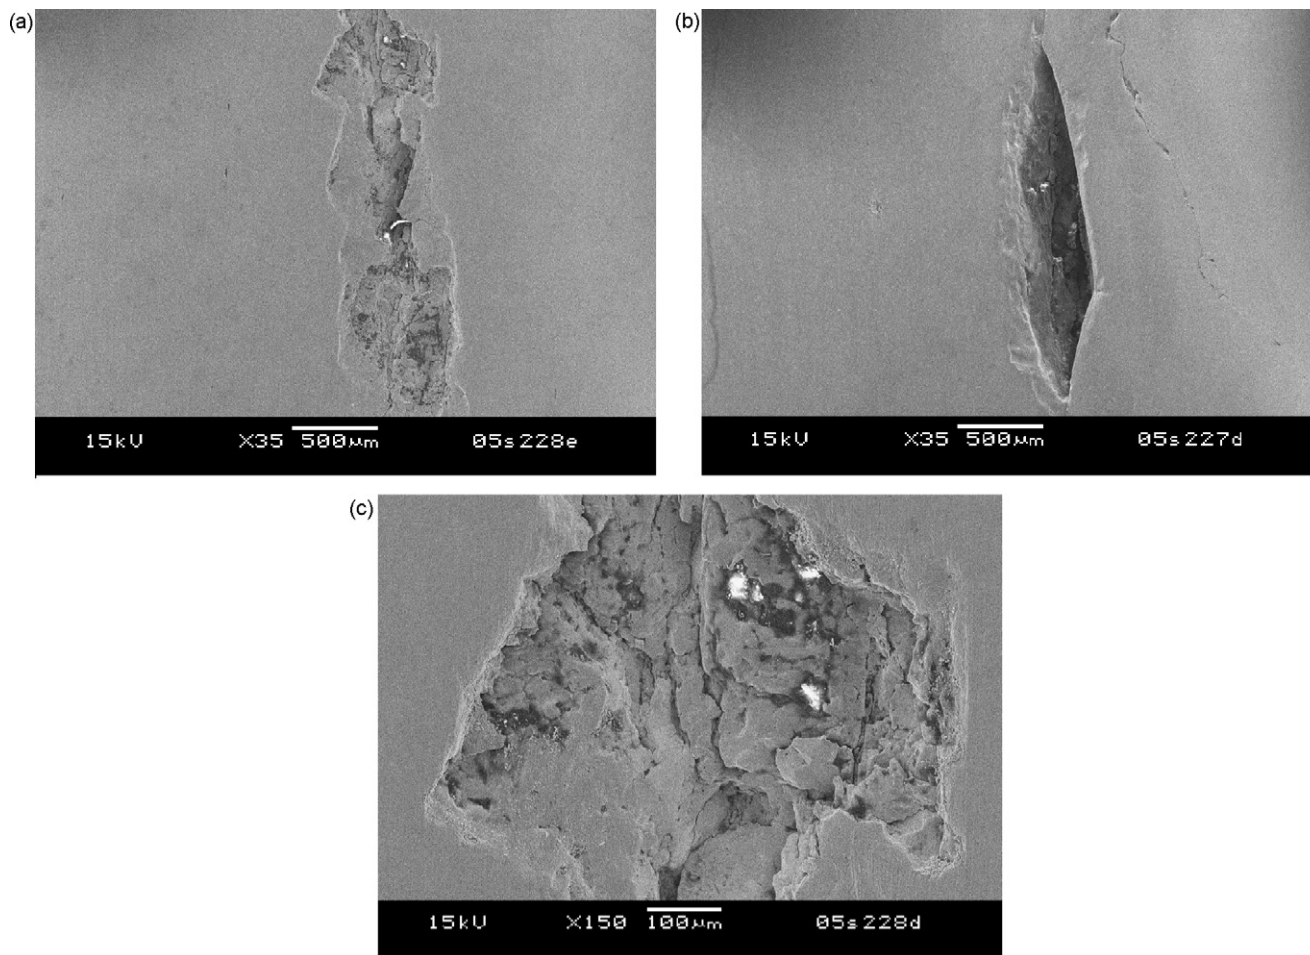
Higher magnification views of the regions associated with die “crack out” are given in Fig. 7(a–c). Comparison of Fig. 7(a) and (b) shows that the LSP-die failed by a flaking process rather than a sharp propagating crack as observed in the standard die. With a higher magnification in Fig. 7(c), it can be seen that there are no sharp or propagating cracks associated with the cracked out region of the LSP-die and that materials has flaked and fallen from the die as opposed to the relatively undeformed and failed section of the standard die in Fig. 7(b).

The “flaked” appearance of the LSP-die failure could be related to corrosion given that the extended life resulted in the die being in the mill for many more days, however more likely the flaked appearance of the LSP-die failure may be related to the interaction of the crack process zone and the deep (and high) compressive residual stress similar to that described by Rosenfield (1981) for sheet rolling dies. In this scenario the die fails by plastic deformation and ultimately “flaking” rather than the easy crack propagation observed in low fracture toughness materials like A2. Given the extended life, it is also possible that the failure of the LSP-die has been

Fig. 7 – SEM images of the most severe regions of the cracks for (a) the LSP-die and (b) the standard die, respectively. (c) A higher magnification of the failed surface of the LSP-die in Fig. 6(a).
